NRL/MR/6180--04-8742

Performance of Fire Protective Coatings Subjected to DC-ARM Wartime Scenario Fires Aboard Ex-USS *Shadwell*

January 16, 2004

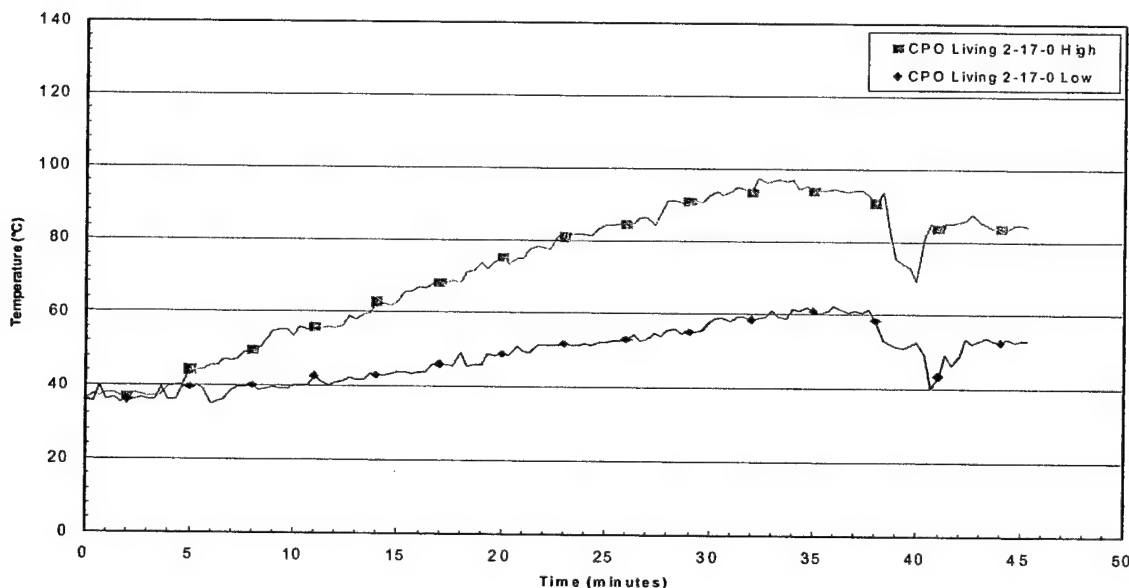
Figure 9. CPO Living Air Temperature Profile

Figure 9 shows upper T increasing at greater rate than lower. This implies upper/lower layer interaction. However, shielded TC separated by NA' vertically will not provide conclusive data for explicit analysis.

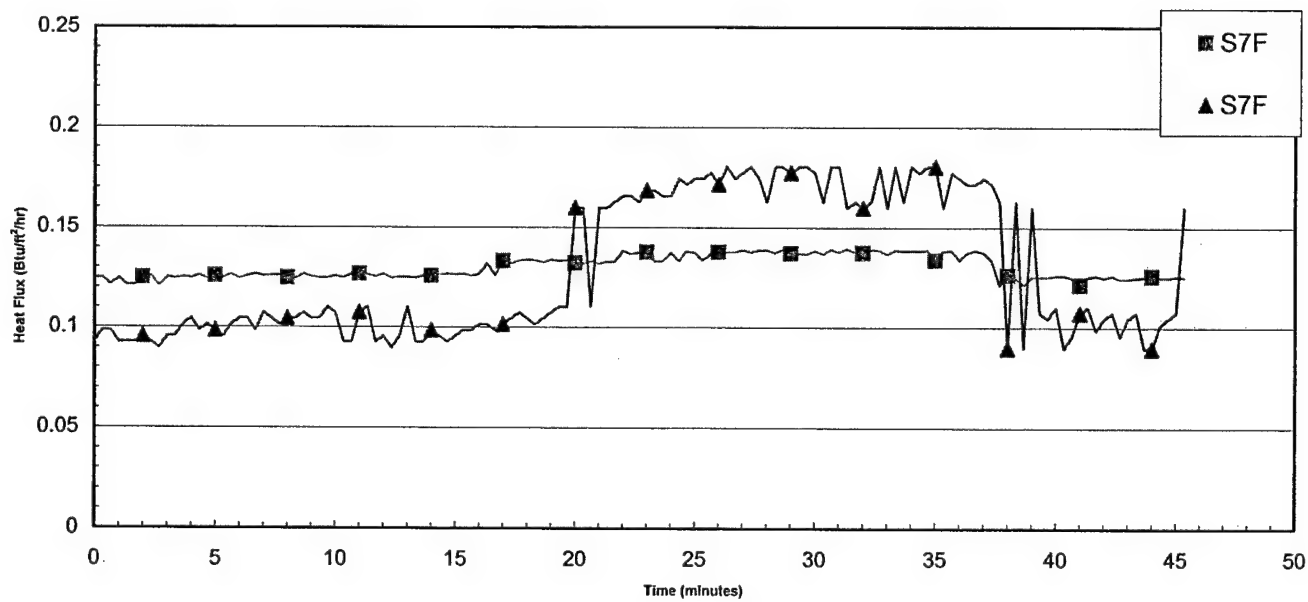
Figure 46. Heat Flux Profile, Panel #7

Figure 46 displays traces of radiant and total heat flux measured from the forward surface of the panel. The area of the panel these instruments were aimed at coincide with the thermocouple trace in Figure 44. The radiant flux trace resembles a step function with a clear, discrete increase at approximately 18 minutes and a slightly greater decrease at approximately 37 minutes.
